**RE: Possum Point Power Station VPDES Permit No. VA0002071:
Removal of Surface Water from Ash Pond E**

Process for Removal of Surface Water from Possum Point Ash Pond E

RECON INSPECTION REPORT

FACILITY NAME: Dominion Possum Point Power Station		INSPECTION DATE: May 13, 2015	
		INSPECTOR: Amy Dooley	
PERMIT No.: VA0002071		REPORT DATE: June 3, 2015	
TYPE OF FACILITY: <input type="checkbox"/> Municipal <input checked="" type="checkbox"/> Major <input checked="" type="checkbox"/> Industrial <input type="checkbox"/> Minor <input type="checkbox"/> Federal <input type="checkbox"/> Small Minor <input type="checkbox"/> HP <input type="checkbox"/> LP		TIME OF INSPECTION: <div style="display: flex; justify-content: space-between;"> 1300 Arrival 1600 Departure </div>	TOTAL TIME SPENT 16hrs
PHOTOGRAPHS: <input checked="" type="checkbox"/> Yes <input type="checkbox"/> No		UNANNOUNCED INSPECTION? <input checked="" type="checkbox"/> Yes <input type="checkbox"/> No	
REVIEWED BY / Date: <div style="text-align: center;"> 6/4/15 </div>			
PRESENT DURING INSPECTION: <u>Susan Mackert, Alan Eudye, Reubin Williams, Whitey Pope, Jeff Marcell</u>

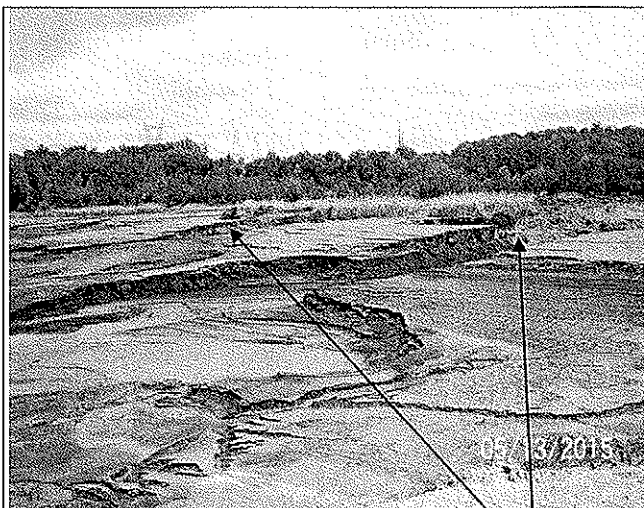
Ash Pond E was observed to have been dewatered, vegetation stripped from the top layer (approximately 8-10 inches), and dewatering channels cut into the ash. (Photo 1)

Photo 1: Dewatered Ash Pond E with dewatering trenches.

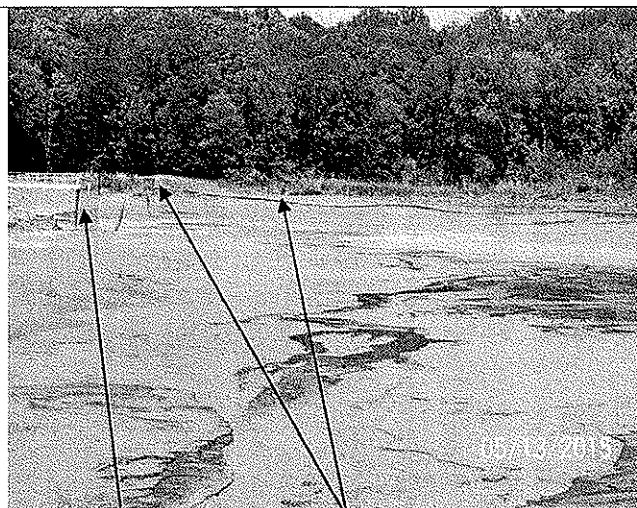
Dewatering activities were carried out via a pump on a floating intake within Ash Pond E, which pumps water into Ash Pond D. A pump in the outfall box associated with Outfall 005 pumps any discharging water back into Ash Pond E. As a result, a discharge out of Pond E has not occurred since May 7, 2015. (Photos 2-6)

Photo 2: Riser structure and pumping infrastructure to pump water from Ash Pond E to Ash Pond D.

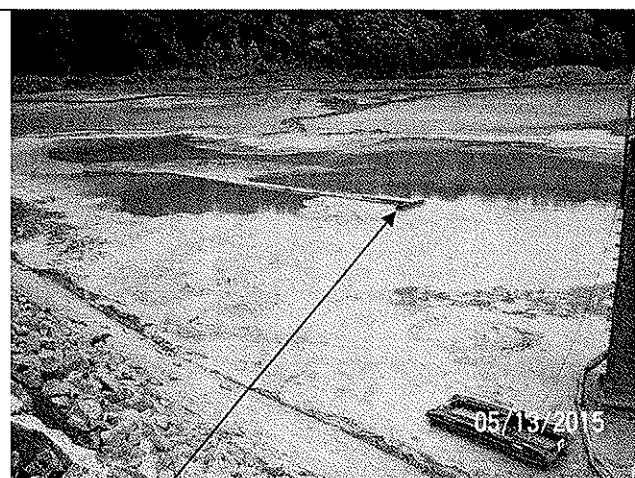
Photo 3: Floating intake on pump.

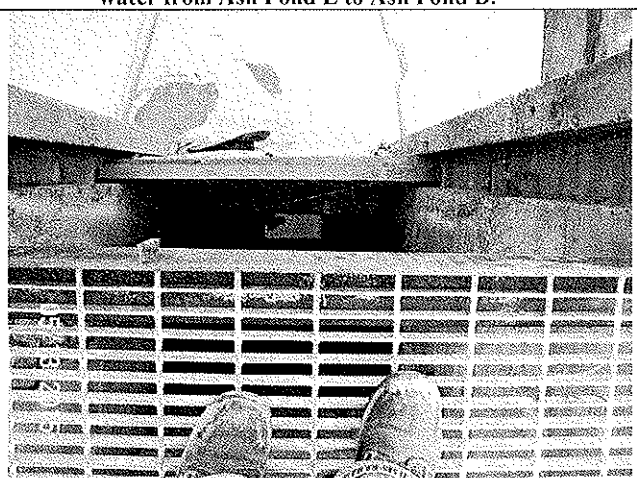
Photo 4: Inside Ash Pond E riser structure.

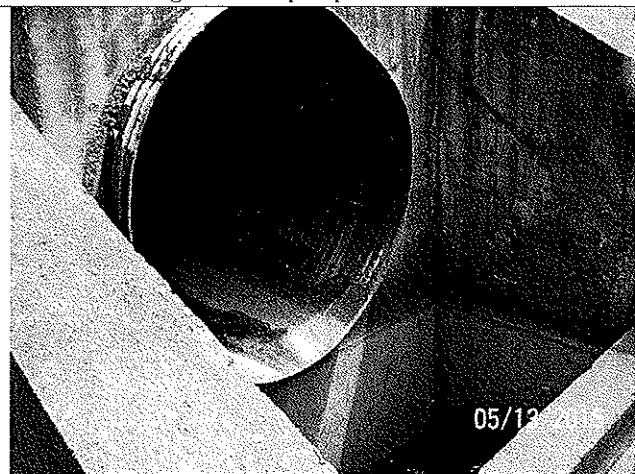
Photo 5: Outfall 005

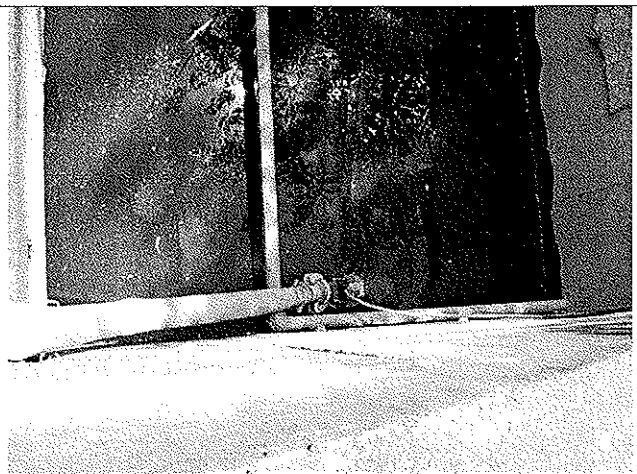
Photo 6: Submersed intake pipe to pump water from Outfall 005 box back into Ash Pond E.

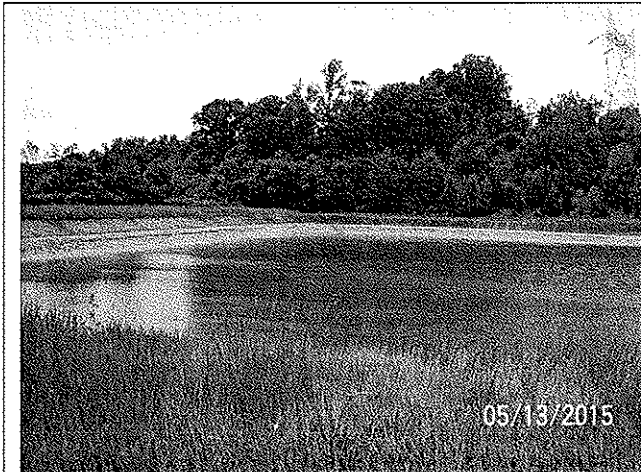
The metals cleaning waste treatment basin (metals ponds) was observed. The metals-ponds had been pumped into Ash Pond E to the maximum extent practicable and considered "empty" by Dominion. (Photos 7)

Photo 7: Metal cleaning pond.

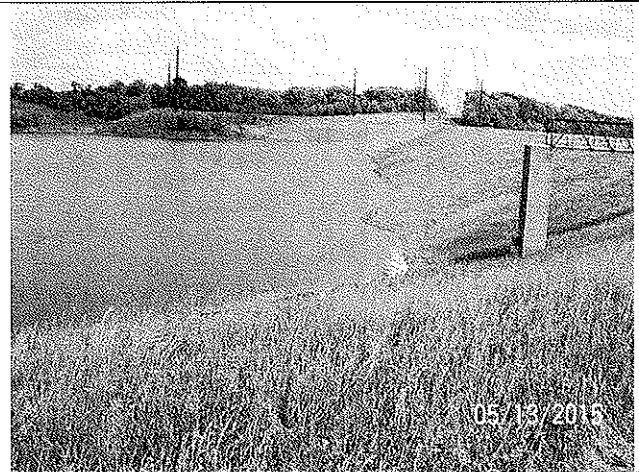
Water level observed in Ash Pond D was lower than the riser structure and piping infrastructure associated with dewatering activities in Ash Pond E were observed. (Photos 8 and 9)

Photo 8: Ash Pond D and riser structure.

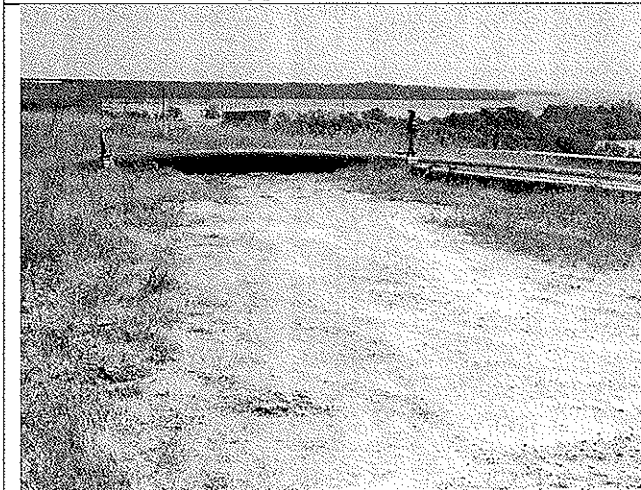
Photo 9: Piping from dewatering activities in Ash Pond E.

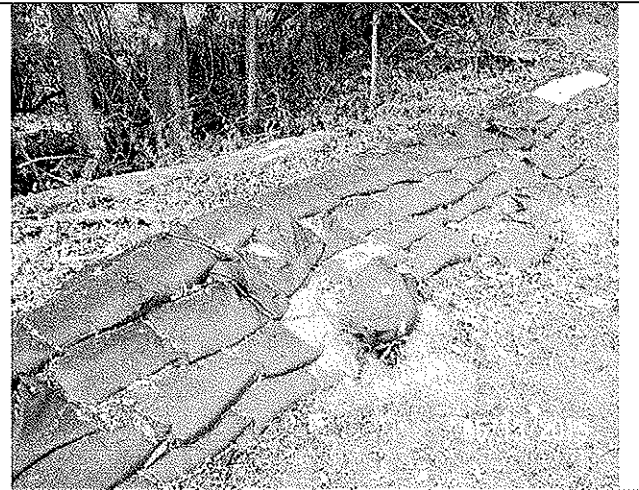
Ash Ponds A, B and C were observed. Dominion has sealed the discharge structure at Ash Pond C with a polyurethane grout in an attempt to reduce/eliminate the discharge from the structure. Additionally, sand bags have been placed along points of the berm/dam along Ash Ponds A and B to address overtopping of the berm. According to Dominion, seepage at Ash Pond A is influenced by standing water and heavy rain events. Toe seepage was observed along two points of the berm of Ash Pond B. A small amount of water was observed in Ash Pond C's discharge structure. (Photos 10-15)

Photo 10: Sand bags installed along previously observed overtopping in Ash Pond A.

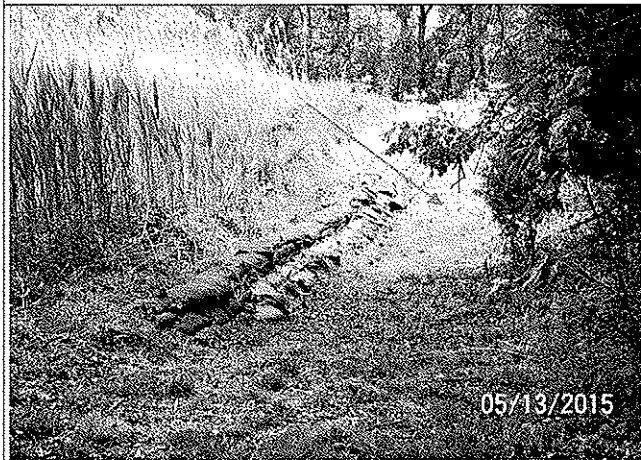
Photo 11: Sand bags installed along previously observed overtopping along Ash Pond A and gravel installed at previous beach (red arrow).

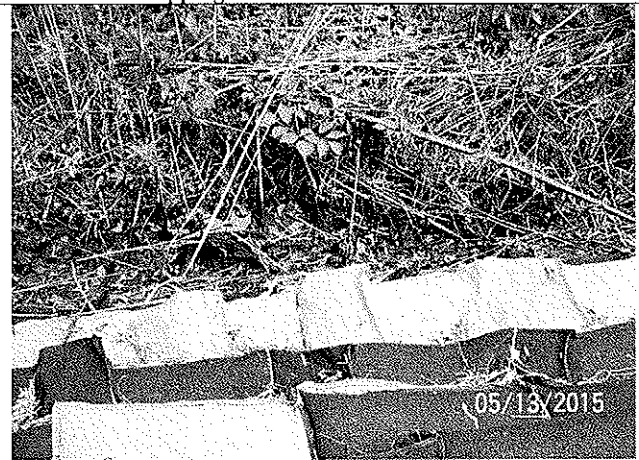
Photo 12: Sand bags installed along previously observed overtopping along Ash Pond A. Standing water evident behind bags.

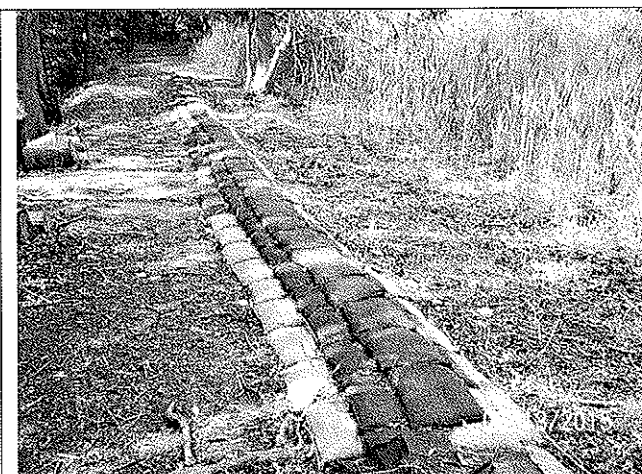
Photo 13: Sand bags installed along previously observed overtopping along Ash Pond A.

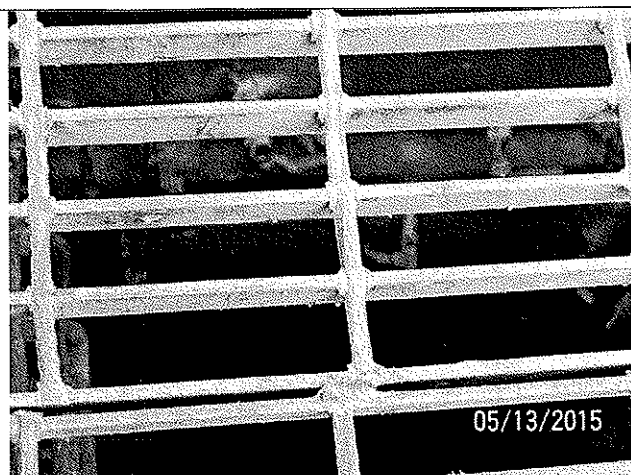
Photo 14: Sealing of discharge structure in Ash Pond C.

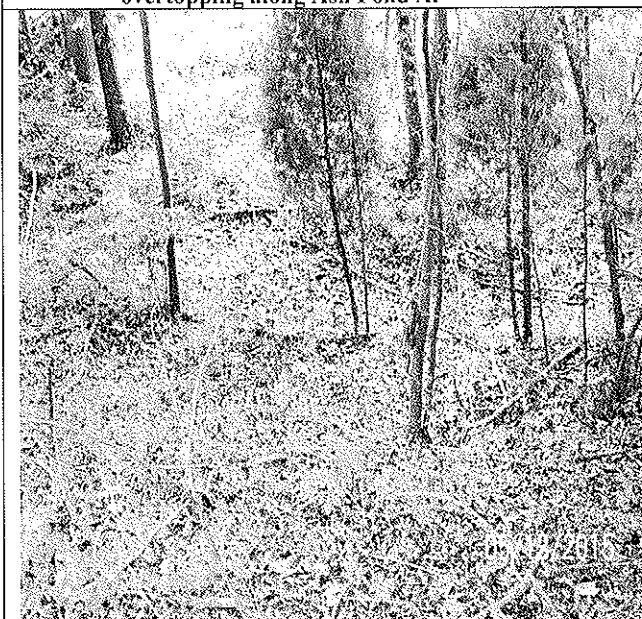
Photo 15: Toe seepage along Ash Pond B's berm.

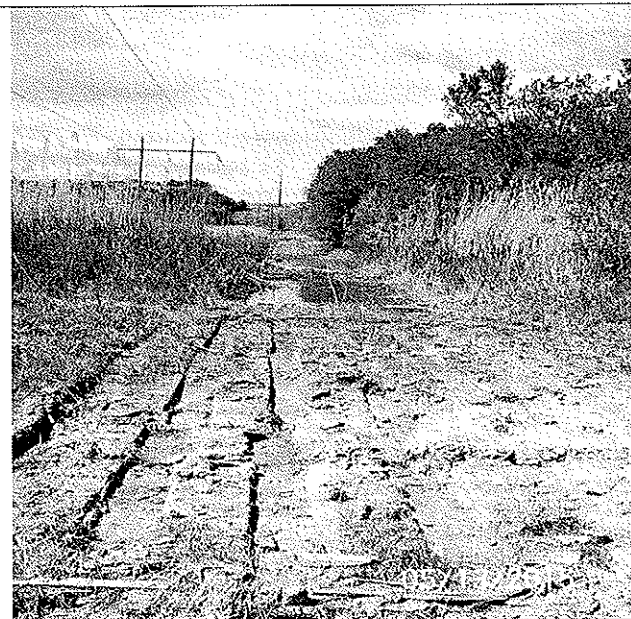
Test pits were observed along Ponds A, B, and C to determine the depth and location of ash in the ponds. (Photo 16)

Photo 16: Test pits at Ash Ponds A, B, and C to determine extent of ash depth.
